**DEPARTMENT OF TRANSPORTATION****DIVISION OF ENGINEERING SERVICES**

Contract #: 04-0120F4Cty: SF/ALA Rte: 80 PM: 13.2/13.9File #: 1.28**WELDING INSPECTION REPORT****Resident Engineer:** Casey, William**Address:** 333 Burma Road**City:** Oakland, CA 94607**Report No:** WIR-028169**Date Inspected:** 12-Aug-2012**Project Name:** SAS Superstructure**OSM Arrival Time:** 700**Prime Contractor:** American Bridge/Fluor Enterprises, a JV**OSM Departure Time:** 1530**Contractor:** American Bridge/Fluor Enterprises, a JV**Location:** Job site**CWI Name:** Salvador Merino**CWI Present:** Yes No**Inspected CWI report:** Yes No N/A**Rod Oven in Use:** Yes No N/A**Electrode to specification:** Yes No N/A**Weld Procedures Followed:** Yes No N/A**Qualified Welders:** Yes No N/A**Verified Joint Fit-up:** Yes No N/A**Approved Drawings:** Yes No N/A**Approved WPS:** Yes No N/A**Delayed / Cancelled:** Yes No N/A**Bridge No:** 34-0006**Component:** OBG**Summary of Items Observed:**

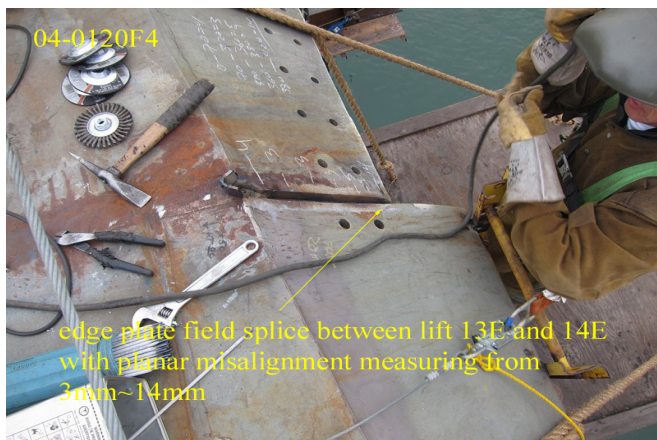
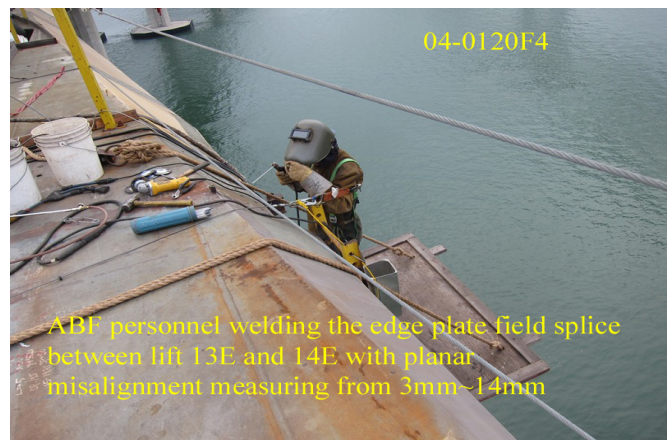
During the Quality Assurance (QA) random in-process visual inspection of the welding operations on the OBG East End, the QA inspector observed ABF personnel welding the edge plate field splice between lift 13E and 14E (EP3018 to EP3028) with planar misalignment measuring from 3mm~14mm. The edge plate thickness at this connection is 20mm and the weld is designated as 13E/14E-G. The QA task leader was notified in writing of the non-compliant issue for further discussion with the Caltrans Structural Materials Representative (SMR) and ABF Management.
